STUDY ON INFRARED THERMOGRAPHIC INSPECTION OF
DE-BONDED LAYER OF AIRPORT FLEXIBLE PAVEMENT

PRESENTED FOR THE
2007 FAA WORLDWIDE AIRPORT TECHNOLOGY TRANSFER CONFERENCE
Atlantic City, New Jersey, USA

April 2007

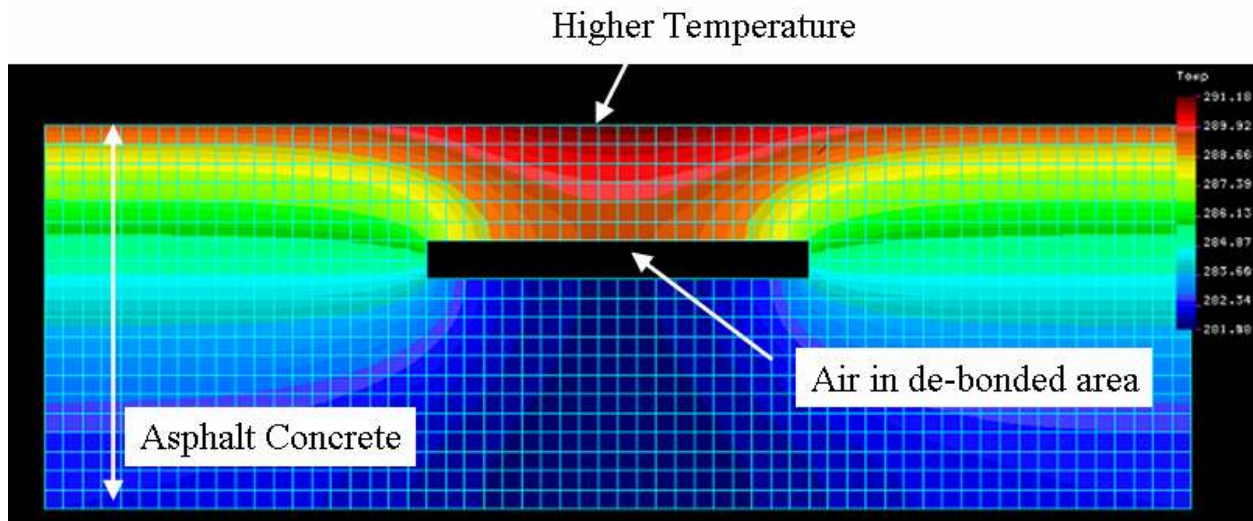
Figure 2. Example Image of Thermal Analysis (Daytime Condition).

thermography is widely used to detect the positions of defects within the concrete piers of roads and railways [2]. The method is based on the surface temperature difference between bonded and de-bonded areas. Since heat transfer is blocked between layers due to air in a de-bonded area (which acts as an insulator), the surface temperature at that area decreases at night and increases in the day compared with that on bonded areas as shown in Figure 2.

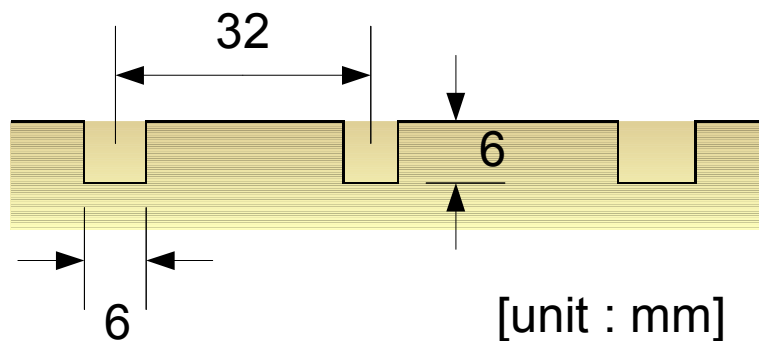
Figure 9. Dimension of Grooves.

Grooves, as shown in Figure 9, are constructed on the surfaces of all runways and some taxiways at all airports maintained by the Civil Aviation Bureau of Japan to drain rain water from the airfield pavement to the shoulder as quickly as possible. However, in the first trial to detect low-temperature areas in infrared images, the grooves interfered because the striped pattern due to grooves was seen clearly in case the image was taken from low height. To solve this problem, another trial inspection was conducted by changing the depression angle at which infrared thermographic images were taken.
